Appendix K:
Utica Harbor Point Redevelopment CM#2
Project, Existing Bulkhead Remedial Concepts,
CME, February 2015

Re: Utica - Harbor Point Redevelopment CM#2 Project
Existing Bulkhead Remedial Concepts
CME Report No. 26959E-02-0215
Page 1 of 2

Re: Utica - Harbor Point Redevelopment CM#2 Project
Canal Corp Inspection of Structure of September 19, 2008
CME Report No. 26959E-01-0215
Page 1 of 2

Structure Inspection Report

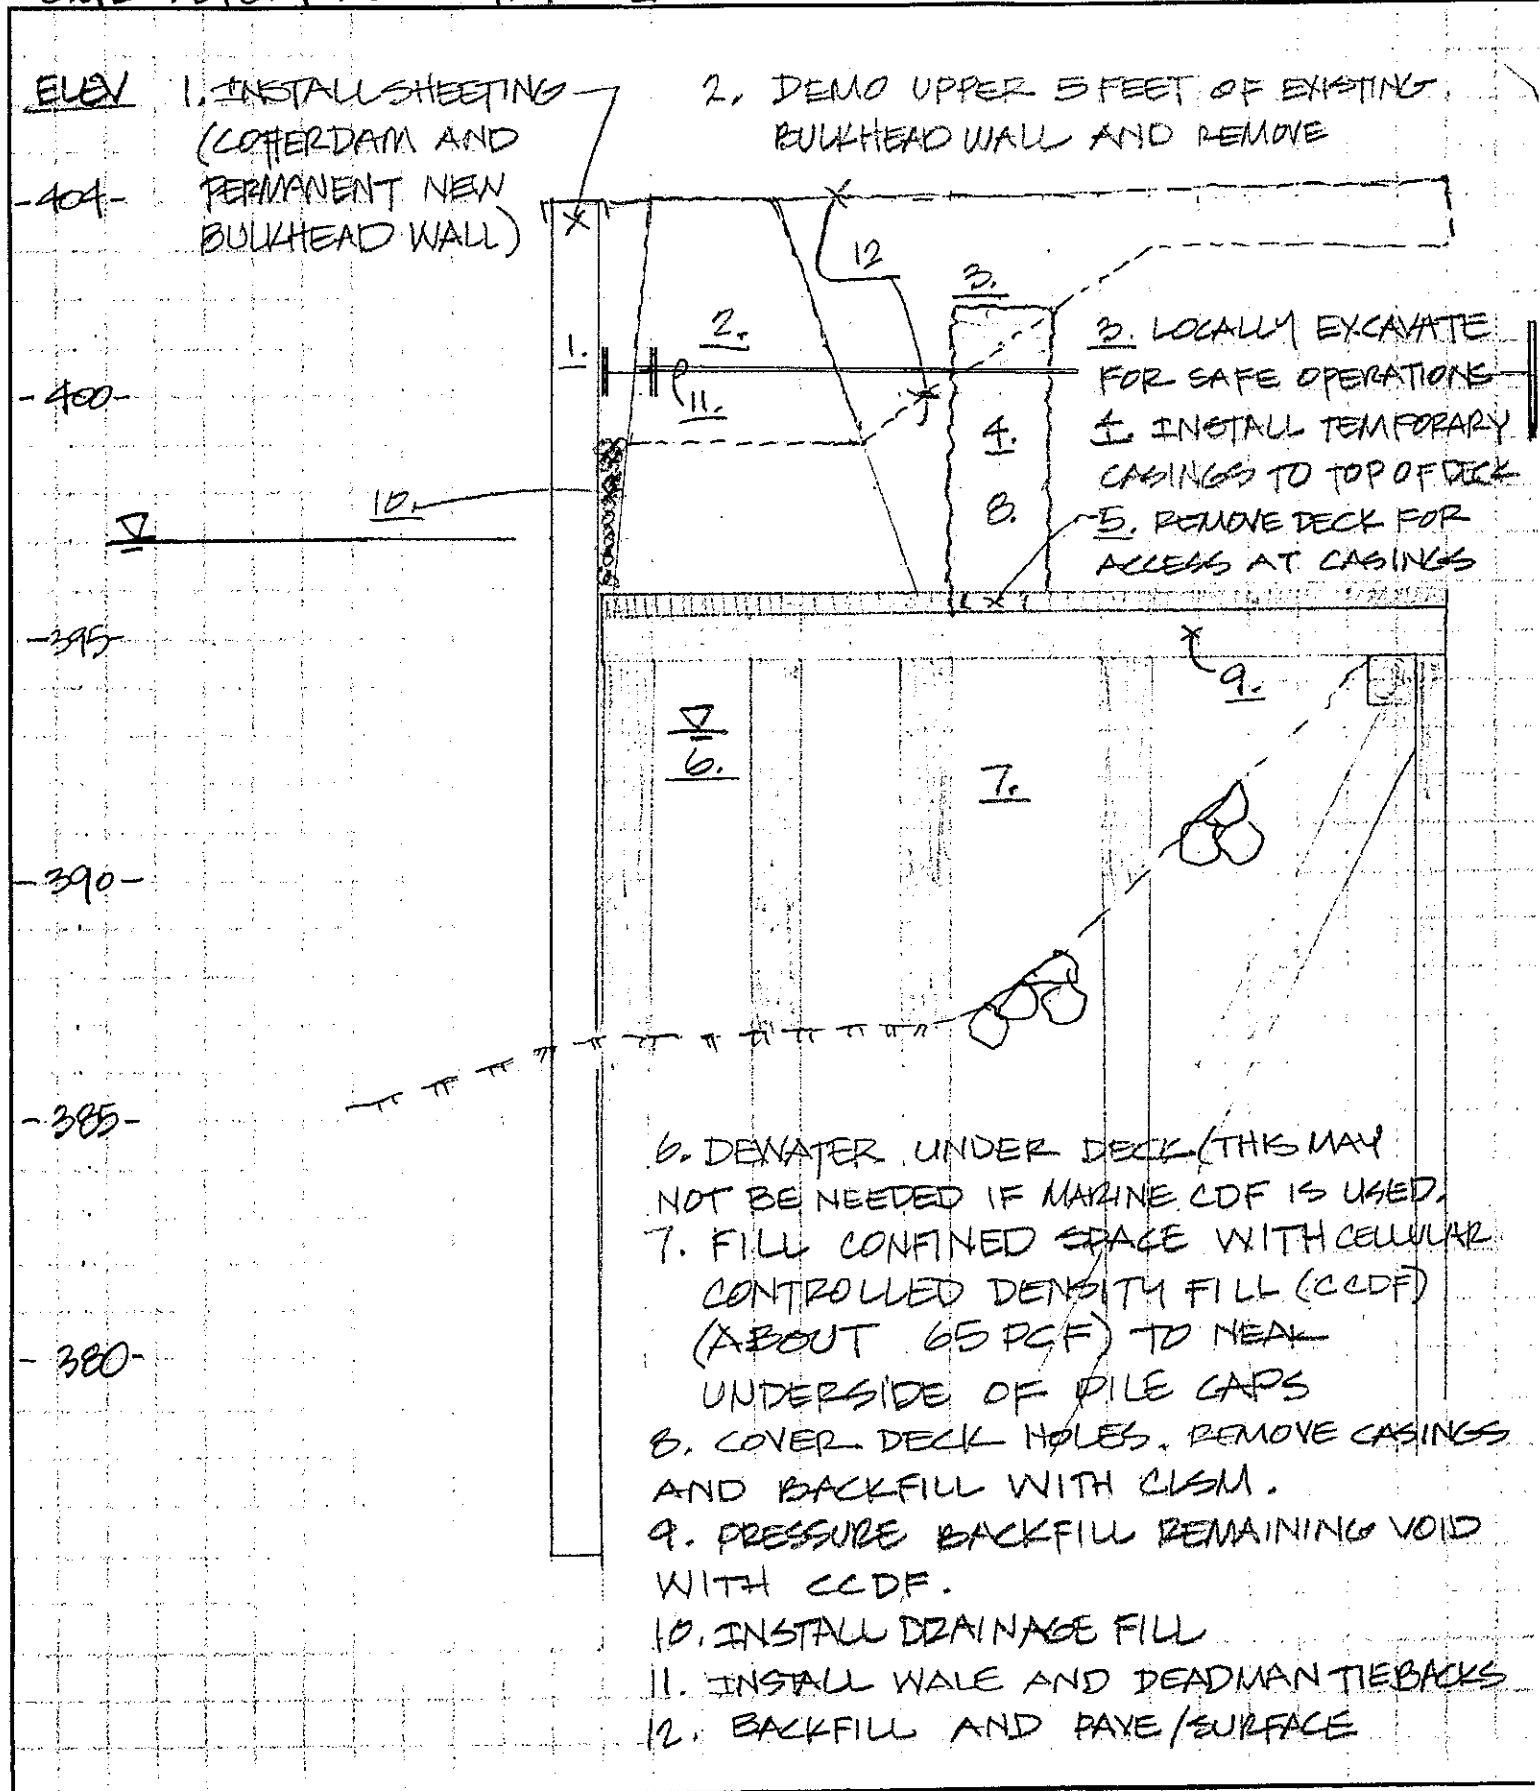
CONCEPT SKETCH

CME's second concept is presented on the attached sketch and is intended for discussion purposes. This concept is about 50% less costly than the first concept and, since the new Bulkhead Wall will be completely backfilled to the mudline, represents a much lower risk alternative by eliminating the sudden collapse and sinkhole risks.

It is recommended that the Concept Sketch be considered and discussed. If no other significantly different concepts are envisioned that capture the attributes desired, then Design Development of the concept should commence.

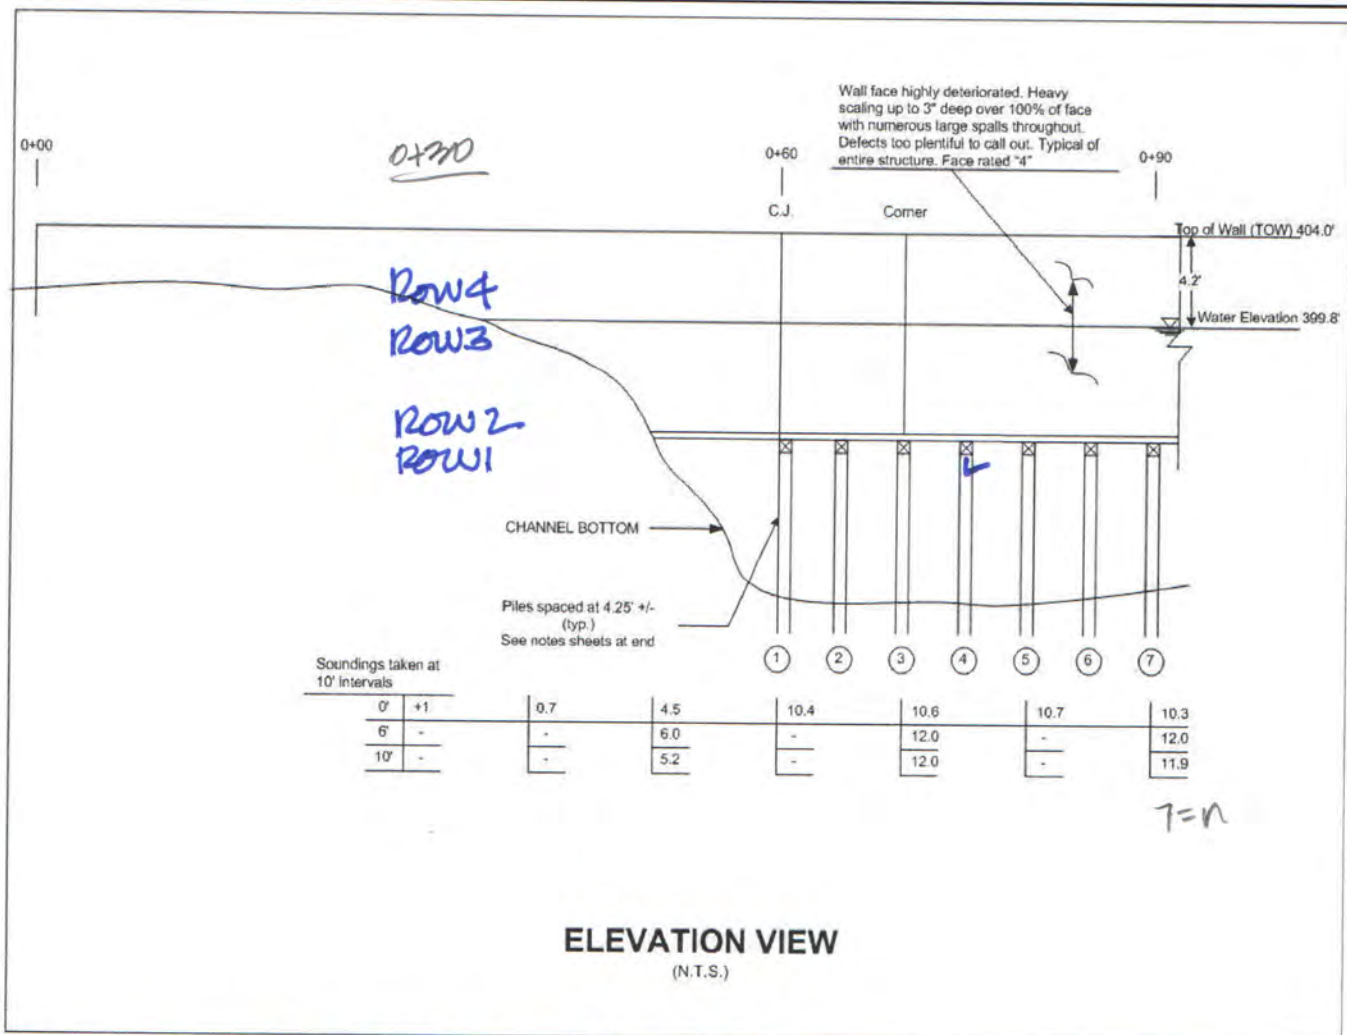
ELEVATION VIEW

- L- Cross Section Loss 10% or More
- D- Displaced Horizontally
- ⊗- No Contact with Pile Cap or ≥ 75% Barring Impaired
- X- Barring Impaired 50% or more
- S- Pile Cap - crushed/split or split Pile

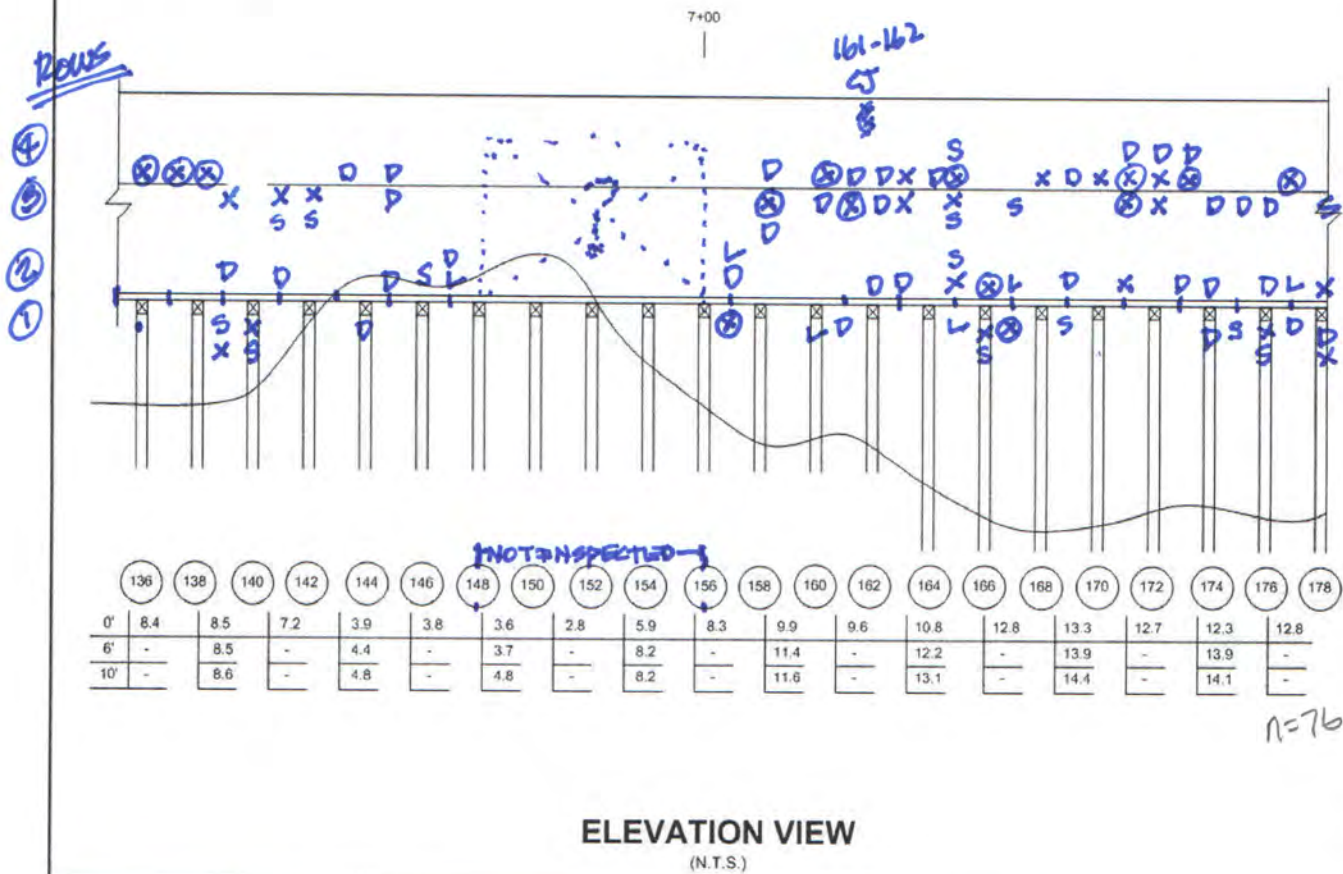
ELEVATION VIEW

139 ① Crushed

140 ① Crushed

148-156 All Rows - Not Inspected

161-162 - CS poor condition

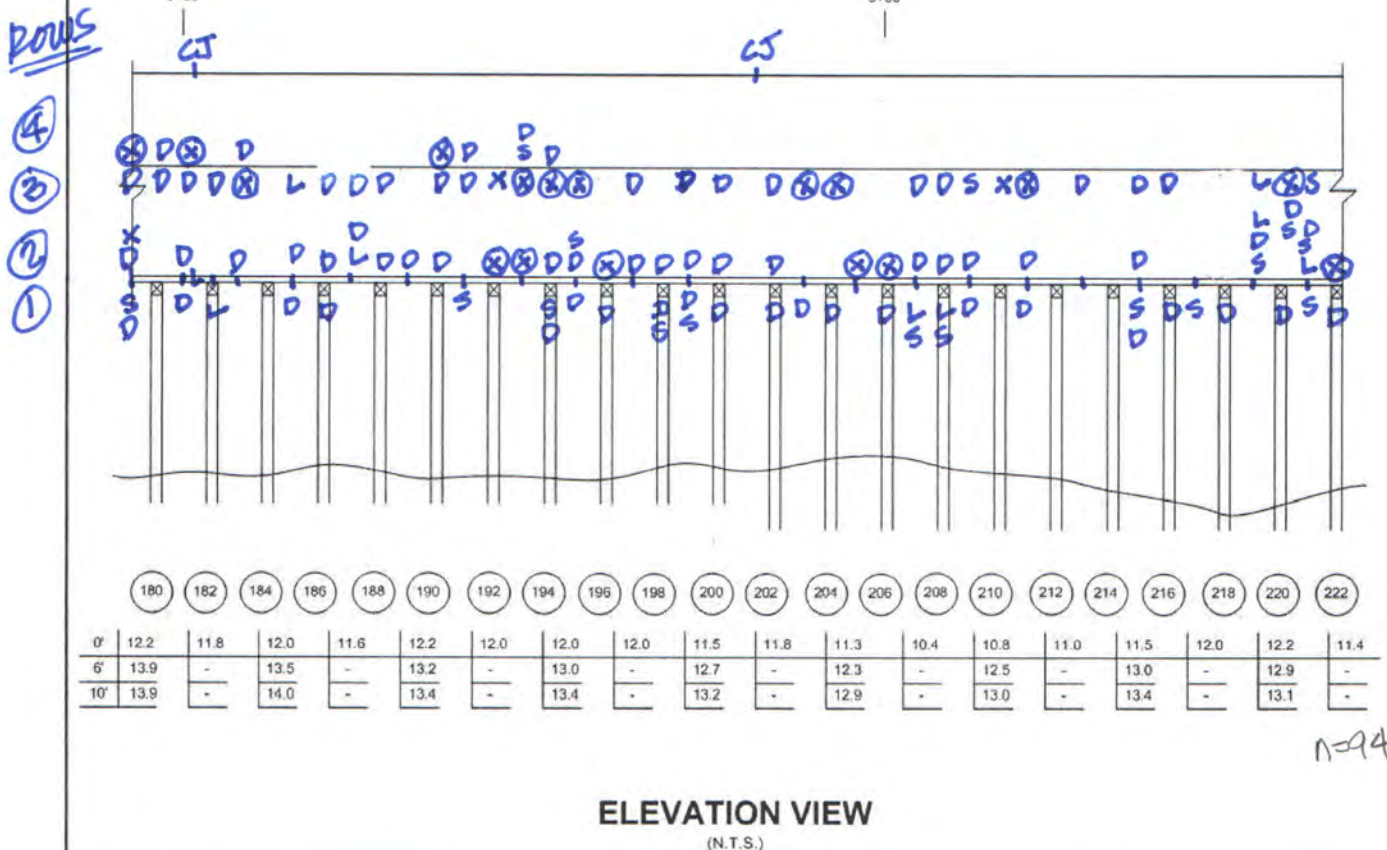
ELEVATION VIEW

181-182 CJ - spalled

181-182 - Beam between pile caps 50% loss-x

201-202 CJ - spalled

216-217 Beam broken

221 - End Cap Split

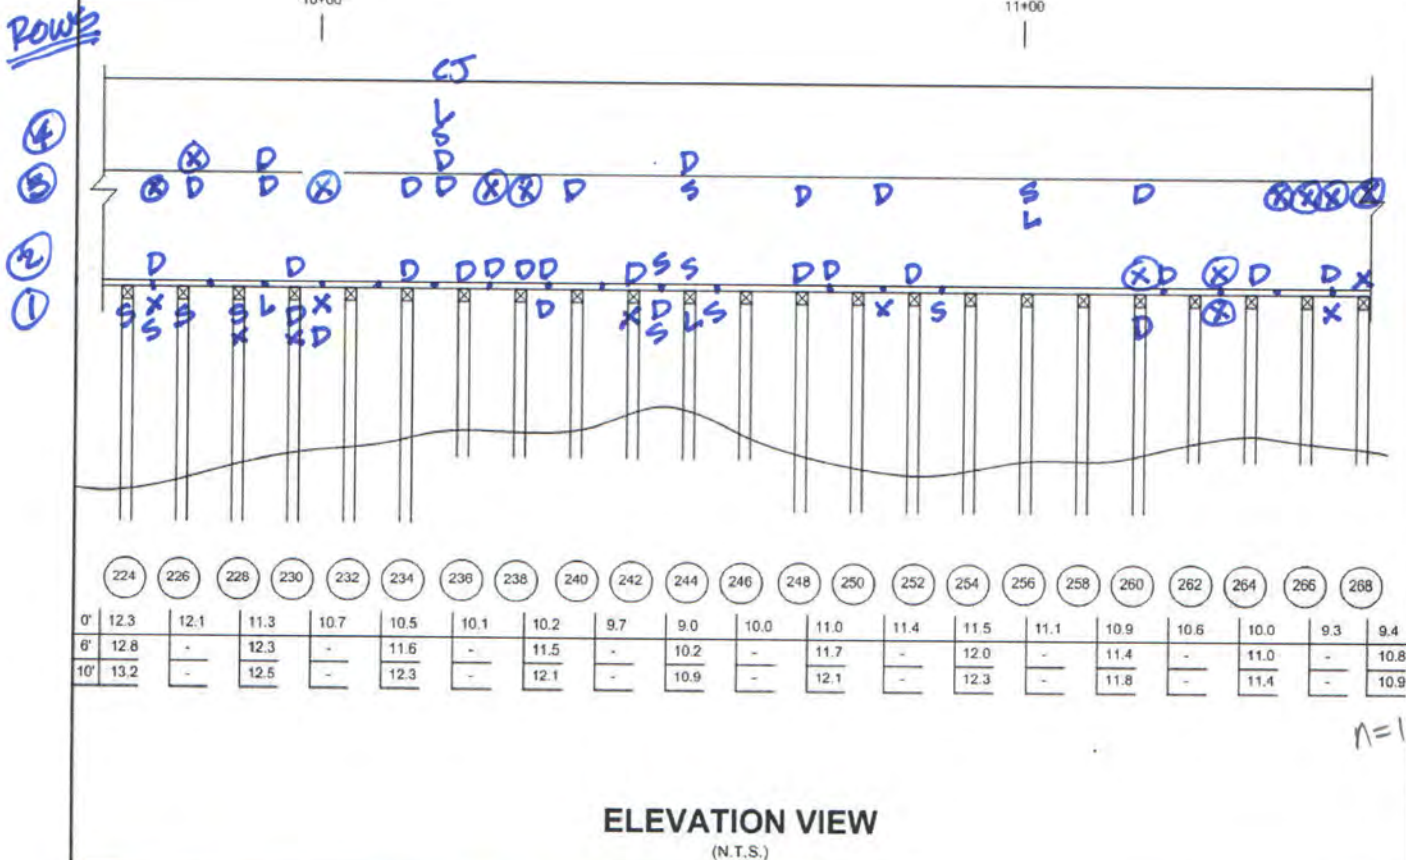
ELEVATION VIEW

233 - ② Rip-Rap to Row 2 on angle

234-235 - CT - 50% Section Loss, spalling to bottom

237 - same as old report

244-245 Penetrating hole goes up @ 45° angle

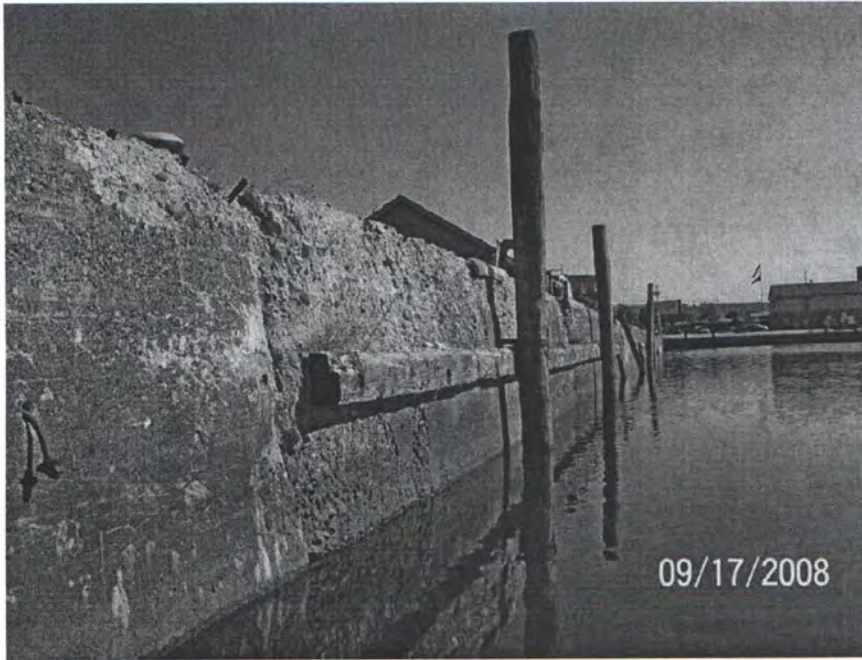
Photo Number: 1

Description:
AT JOINT STA 0+70-STA 1+10
HEAVY SCALING
APPROXIMATELY 3 FT DOWN
FROM TOP OF WALL

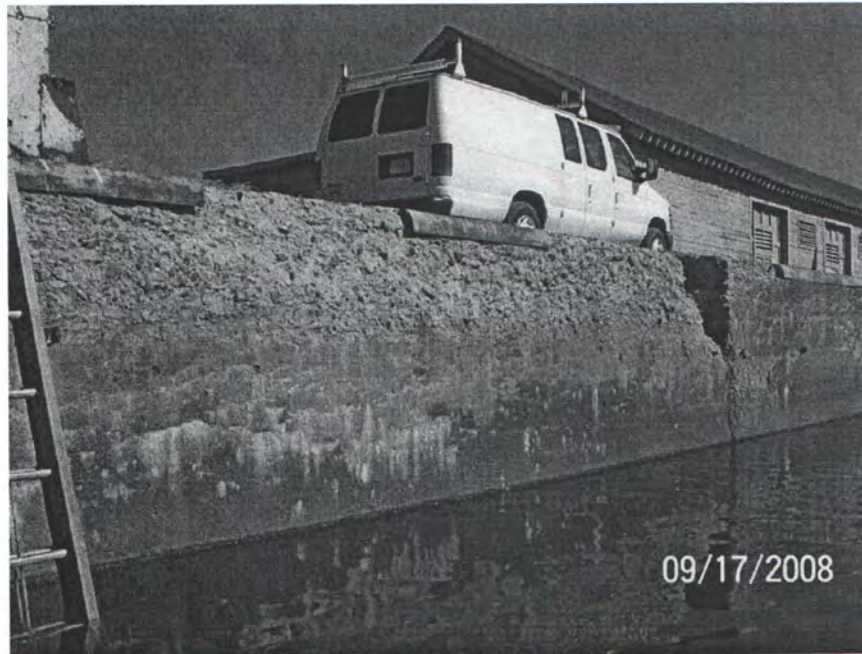
Photo Number: 2

Description:
HEAVY SCALING UP TO JOINT
LOSS OF CONCRETE UP TO 1
FOOT PENE.
2 FT FROM TOP
STA 1+80 - STA 2+00

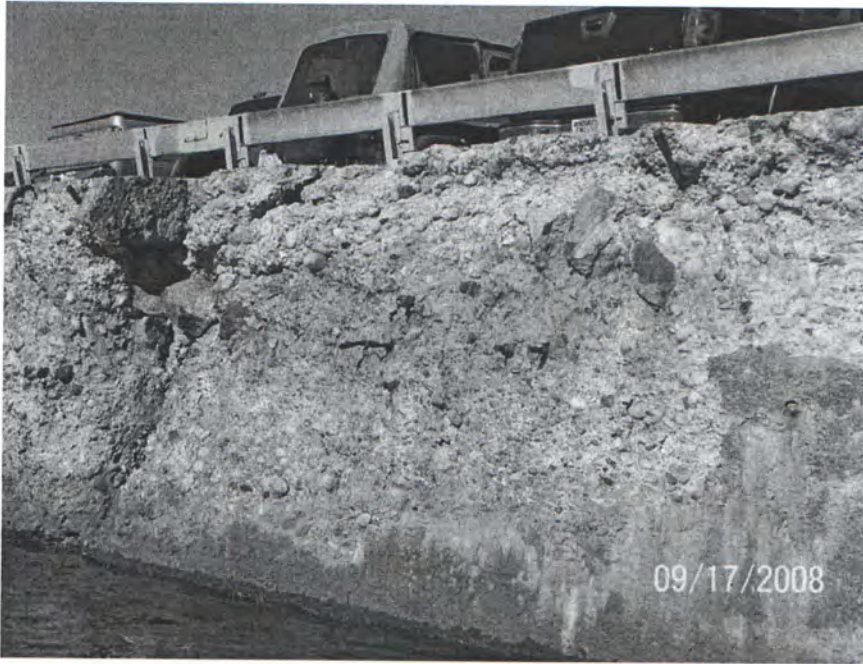
Photo Number: 3

Description:
HEAVY SCALING FROM TOP TO
WATER LEVEL
MAX PENE. 1'
TYPICAL 6"
STA 5+90 - STA 5+95
