Appendix K:
Utica Harbor Point Redevelopment CM#2
Project, Existing Bulkhead Remedial Concepts,
CME, February 2015

Re: Utica - Harbor Point Redevelopment CM#2 Project
Existing Bulkhead Remedial Concepts
CME Report No. 26959E-02-0215
Page 1 of 2

Re: Utica - Harbor Point Redevelopment CM#2 Project
Canal Corp Inspection of Structure of September 19, 2008
CME Report No. 26959E-01-0215
Page 1 of 2

Structure Inspection Report

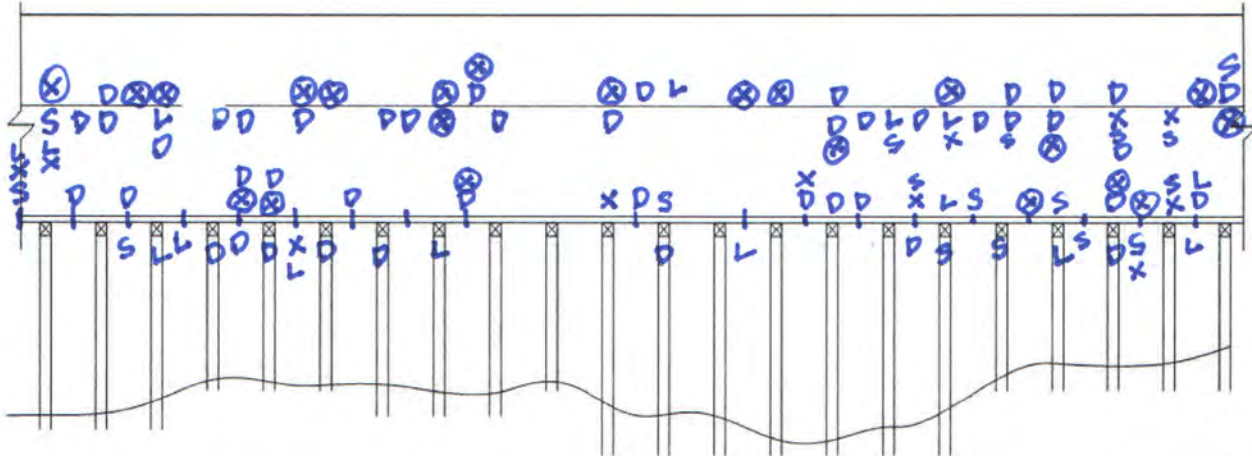
92 94 96 98 100 102 104 106 108 110 112 114 116 118 120 122 124 126 128 130 132 134

0'	12.2	12.0	11.6	10.8	10.7	10.7	11.2	11.1	10.7	12.0	12.2	13.0	12.6	12.1	10.6	10.0	10.0	9.5
6"	-	12.9	-	12.8	-	13.0	-	12.7	-	13.2	-	14.9	-	13.2	-	12.0	-	10.3
10"	-	13.2	-	13.0	-	13.5	-	13.0	-	13.8	-	14.8	-	13.0	-	12.2	-	10.6

161-162 - CS poor condition

181-182 CJ - spalled

201-202 CJ - spalled

216-217 Beam broken

234-235 - CT - 50% Section Loss, spalling to bottom

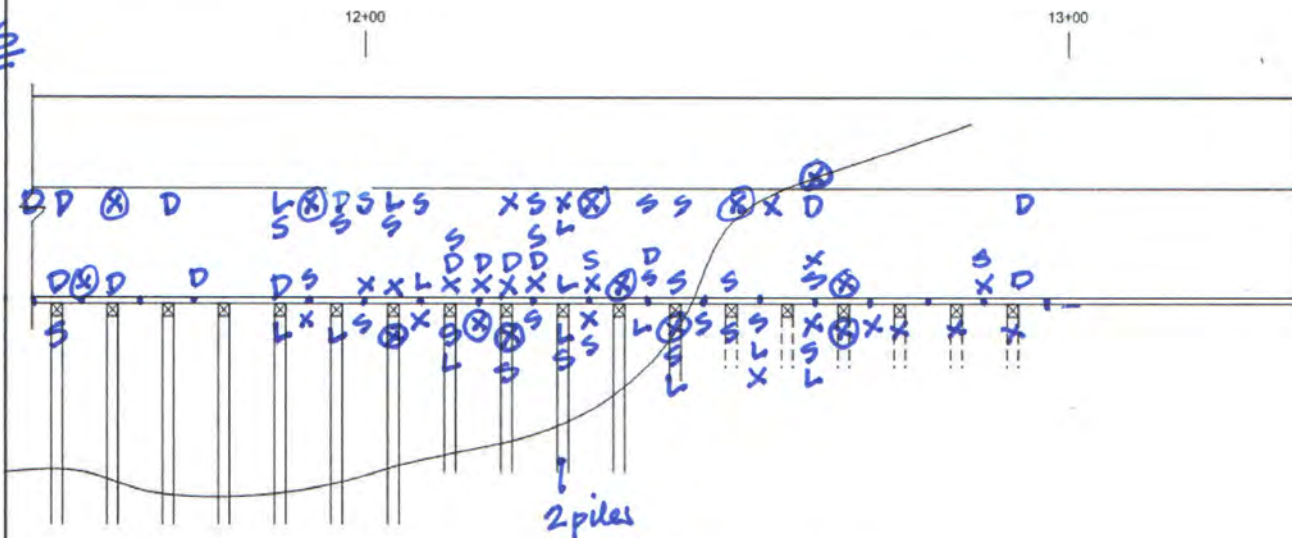
270	272	274	276	278	280	282	284	286	288	290	292	294	296	298	300	302	304
0'	11.0	11.7	11.8	11.8	11.0	10.4	9.5	8.8	7.2	2.5	0.0	+1	+2				
6'	-	12.4	-	12.4	-	10.7	-	8.8	-	2.6	-	0.0	-				
10'	-	12.5	-	12.8	-	11.5	-	9.1	-	2.3	-	0.0	-
